Update on Washington State School Seismic Safety Assessment

to the Capital Budget Committee

Summary of Project

- Evaluate a representative sample of school buildings for geologic and engineering hazards (220 buildings total, 15 of which received engineering concept-level seismic upgrade designs). Funded by the 2017-2019 capital budget
- Extrapolate results to other similar schools statewide
- Determine what it may cost to complete these seismic assessments statewide
- Determine what it may cost to get public school buildings seismically upgraded to meet current seismic safety standards

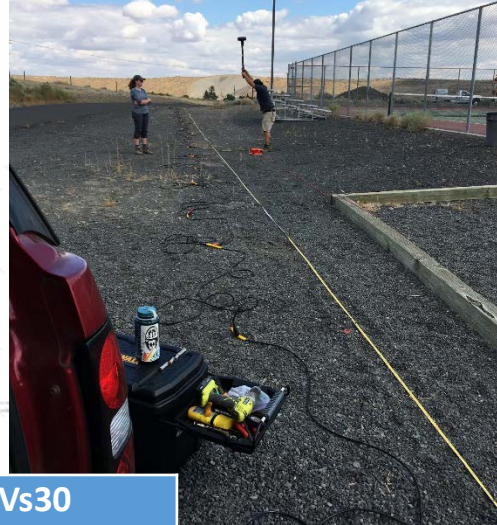
How schools were assessed - Geology

Seismic site class assessment of the soils at the facilities helps to determine the expected level of earthquake shaking. This is used in engineering calculations for seismic upgrade requirements.

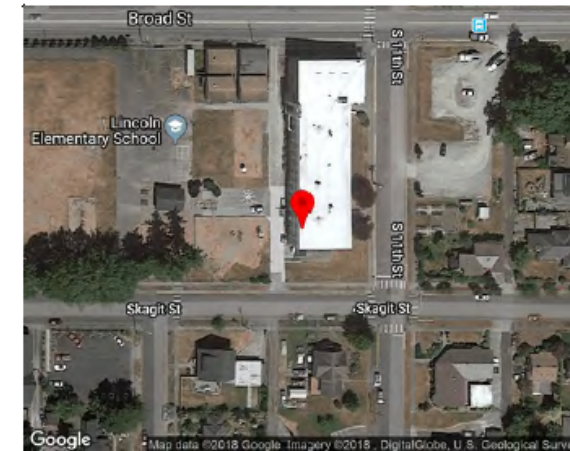
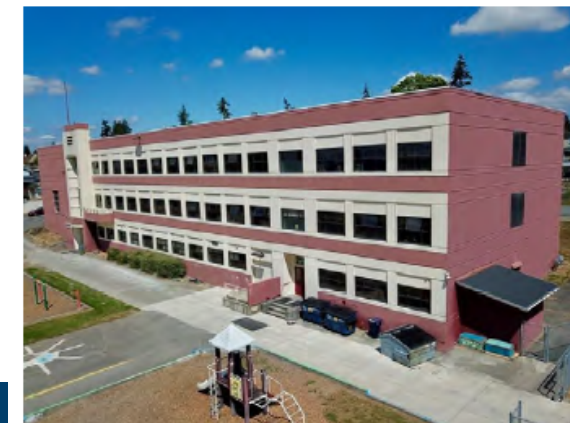
1.1 Mount Vernon, Lincoln Elementary School, Main Building

Building Name:	Main Building
Facility Name:	Lincoln Elementary School
District Name:	Mount Vernon
Latitude:	48.415
Longitude:	-122.328
ICOS Object ID:	795
ICOS	
County/District ID:	29320
ICOS Building ID:	12009
Enrollment:	373
Gross Sq. Ft. :	40,002
Year Built:	1938
Number of Stories:	3
SXS BSE-2E:	1.087
SX1 BSE-2E:	0.452
ASCE 41 Level of Seismicity:	High
Site Class:	C
Liquefaction Potential #1:	low to moderate
Liquefaction Potential #2:	Low to Moderate
Tsunami Risk:	None

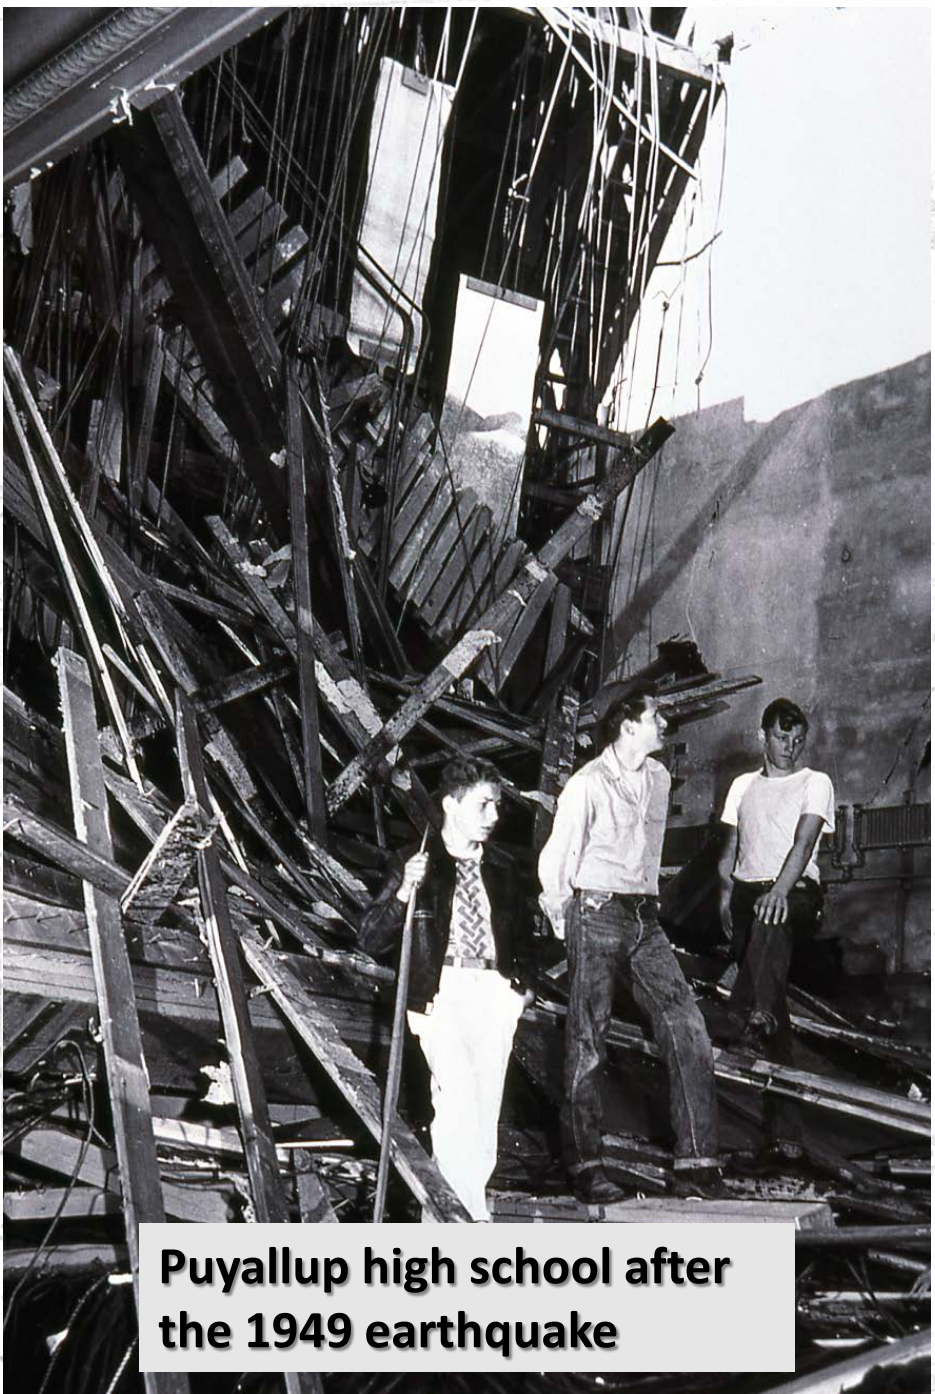
**Puyallup high school after
the 1949 earthquake**

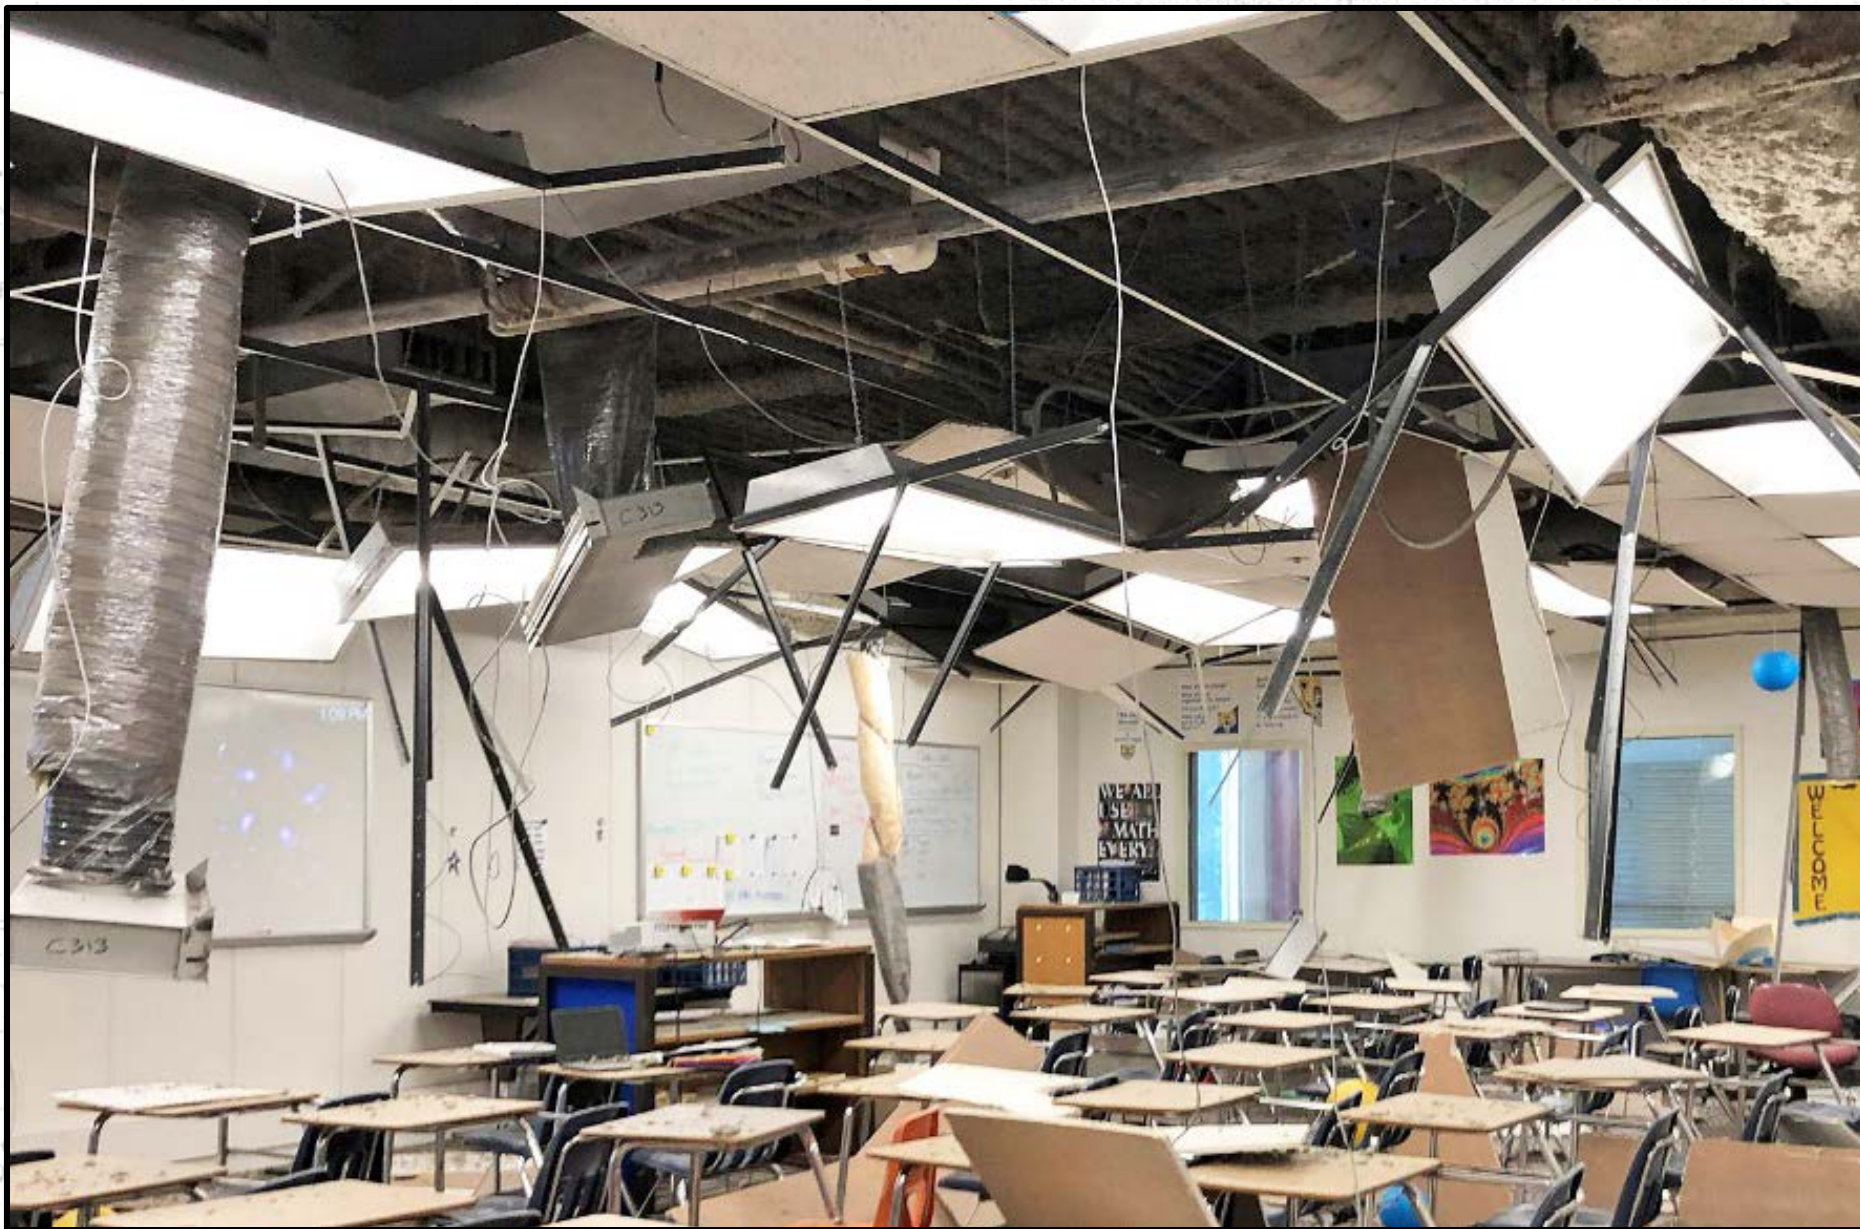
Extensive Suspended Ceiling System Collapse in High School Classroom from M7.0 Anchorage Alaska Earthquake. (Reid Middleton Photo)

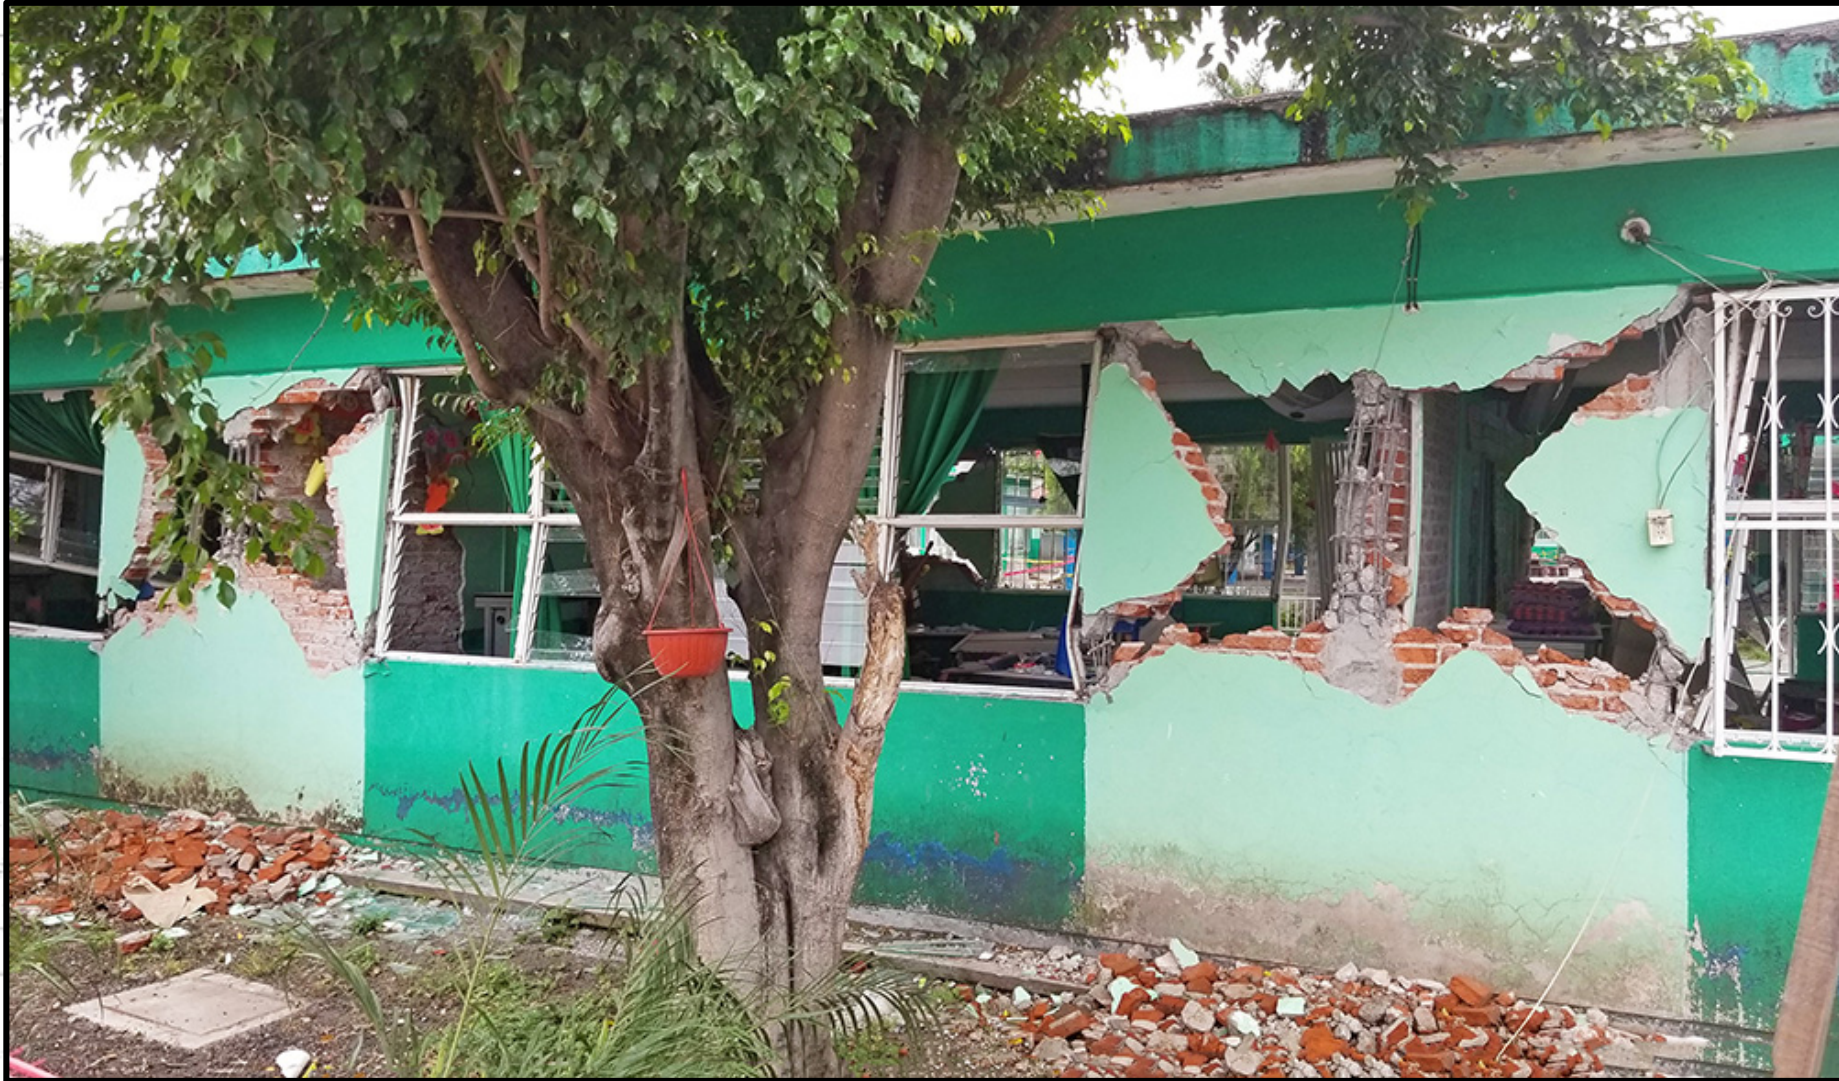
Damaged Primary School in Central Mexico 2017. Wall Failure Due to Diagonal Tension in Unreinforced Masonry Bearing Wall. Many older Washington State school buildings are constructed similarly. (2017 M7.1 Central Mexico Earthquake Reconnaissance Report, Reid Middleton, Inc.)

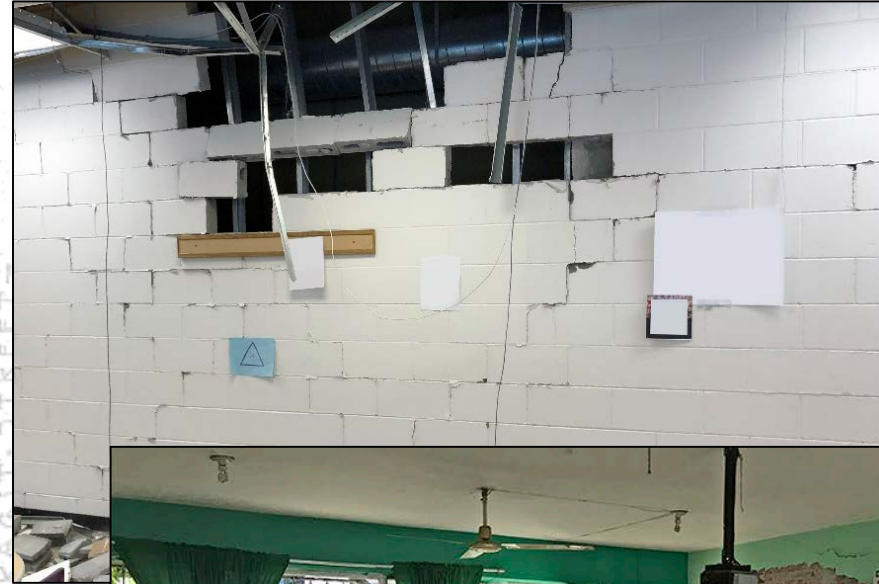
Structural Components

- Inadequate Building Lateral Strength
- Inadequate Load Path From Roof to Foundation
- Weak Roof Edge Beam Strength
- Inadequate Cross-Roof Connections
- Inadequate Reinforcing Steel in Walls
- Walls Too Thin Compared to Height
- Roof-to-Wall Connections Not Strong Enough

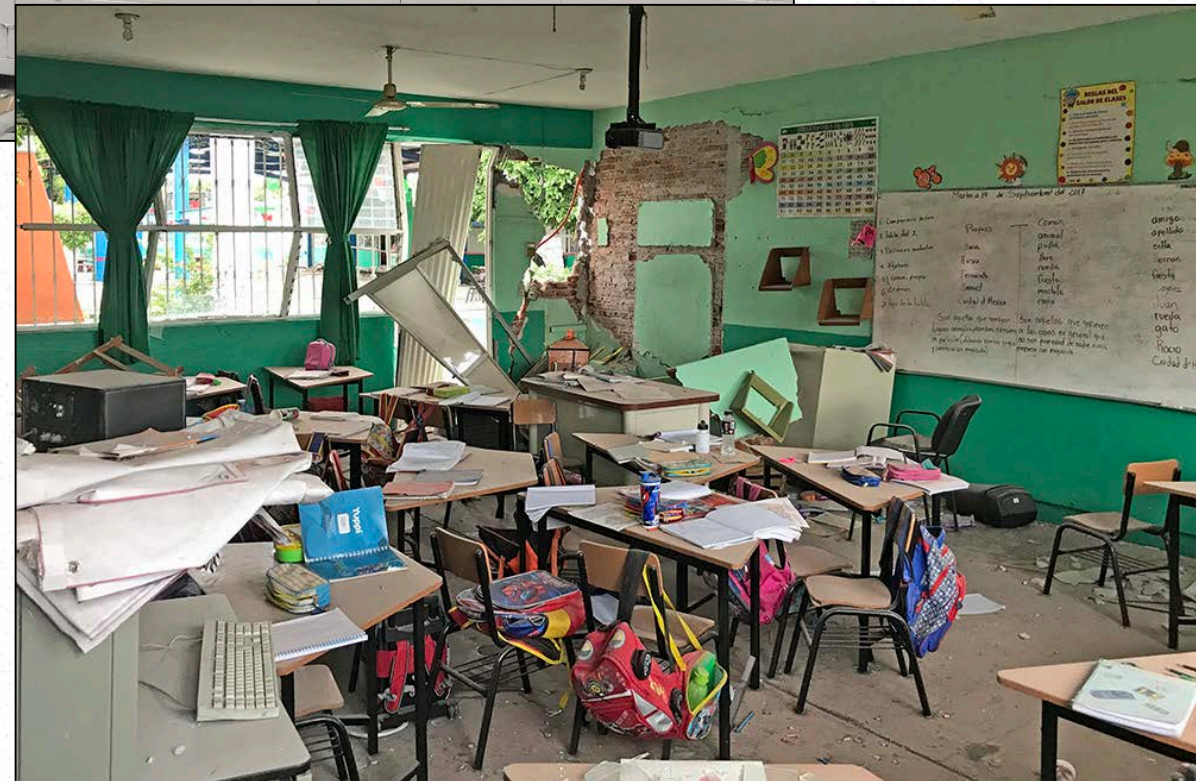
Architectural Finishes and Mechanical/Electrical Components

- Inadequately Anchored or Braced Mechanical/Electrical Equipment
- Inadequately Braced Fire Sprinkler Piping and Lack of Flexible Couplings
- Poor Ceiling Clearance for Fire Sprinkler Heads
- Inadequately Supported Light Fixtures, Ceilings and Emergency Power Equipment
